## 8.1 VIRGIN LAKE

### 8.1.1 An Introduction to Virgin Lake

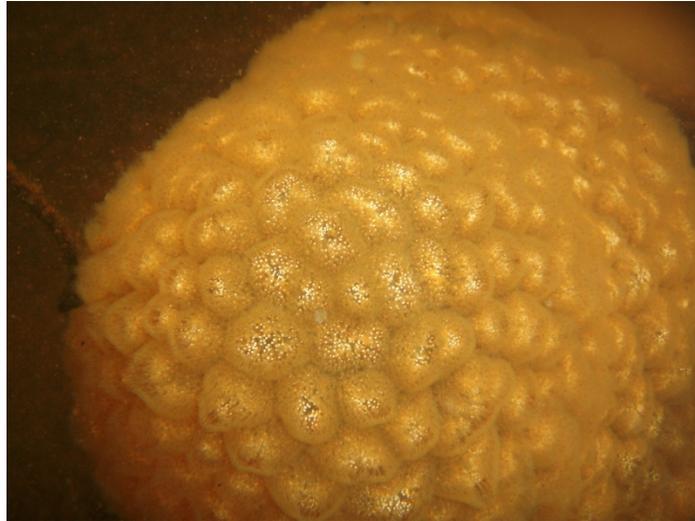
*Many species observed during aquatic plant surveys. Several bryozoans (aquatic invertebrates consisting of colonies of microscopic organisms called “zooids” – pictured to the right), some relatively large in size, spotted as well.*

Photo 8.1.1-1 Bryozoan from Virgin Lake, Oneida County

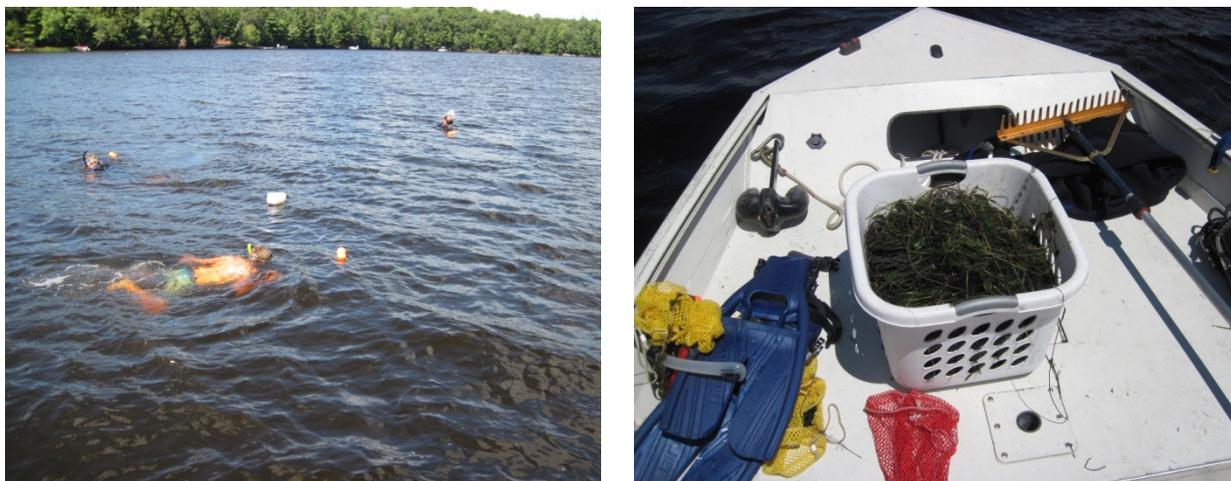
**Photo 8.1.4-1 a) Virgin Lake Eurasian water milfoil hand harvesting, and b) Hand harvesting results.** Hand harvesting occurred in July and September of 2011.

On July 8, 2011, Onterra staff visited Virgin Lake to hand harvest Eurasian water milfoil plants located within the colony. Because of the relatively shallow depth, snorkeling gear was utilized. Two staff members repeatedly swam to the lake bottom and removed Eurasian water milfoil by the roots of the plant. Plants were carefully placed into mesh bags following extraction from the sediment. A third staff member remained in the boat, unloading the mesh bags periodically from the snorkelers and grabbing plant fragments from the water with a pool skimmer on an extendable pole. Weather conditions were good, however visibility into the water column and under the water was impaired by the naturally stained water of the lake. One laundry basket (approximately 50-70 plants) was filled following the removal efforts, which lasted a little over an hour, and no plants were observed on post-removal inspection of the area.

Following reports from TLWA members that more Eurasian water milfoil existed within the previously marked colony, Onterra staff members revisited the lake on September 8<sup>th</sup> of the same year to conduct plant removal again. This time, three staff members donned snorkeling gear while a fourth staff member emptied mesh bags and scooped plant fragments from the surface. About 35 plants were pulled during this time, though stained water was again an issue the snorkelers faced and some single plants were likely left behind.
